Inspection Report

Minerals Regulatory Program

Mine Name: Bald Knoll	Permit Number: M/025/0012
Operator Name: MMG Mining	Inspection Date: June 3, 2009
Inspector(s): Lynn Kunzler	Time: 11:45 am
Other Participants: None	Mine Status: Partial Reclamation

Operator requested inspection to release a portion of the area that had been reclaimed.

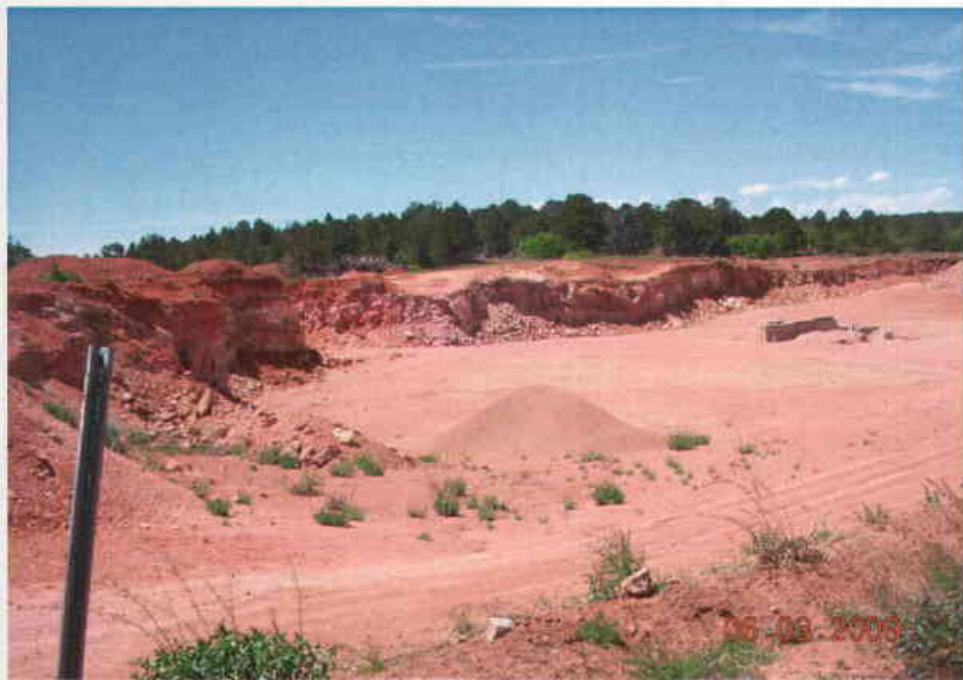
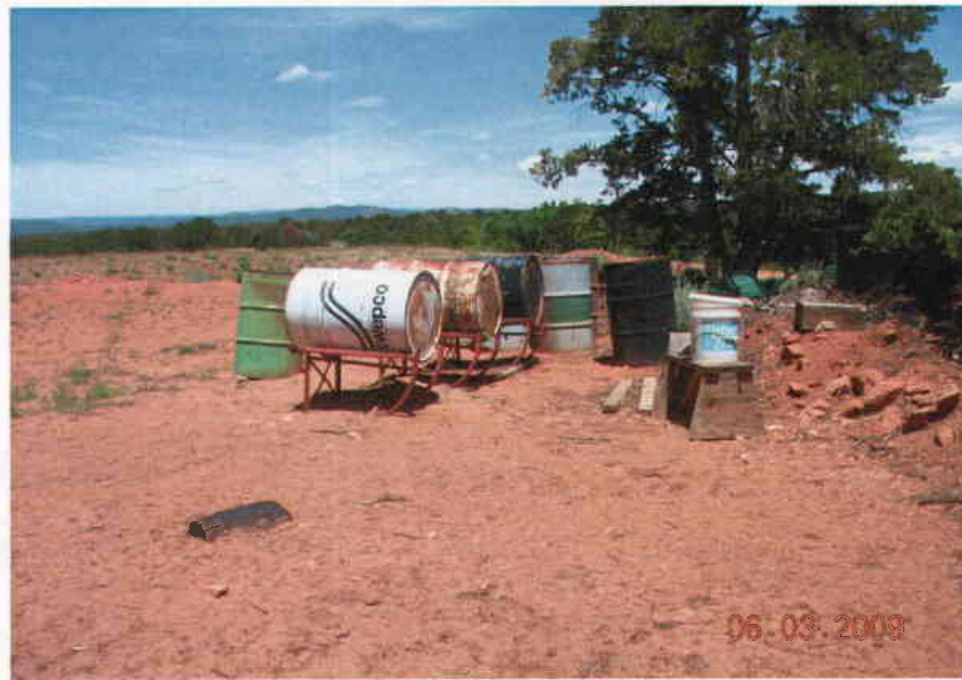
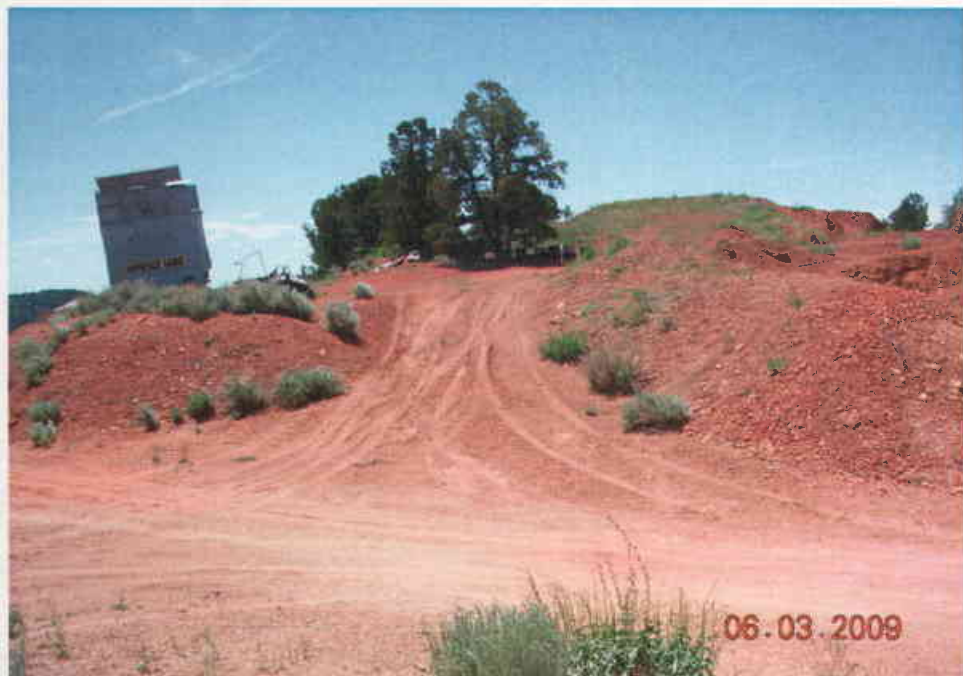
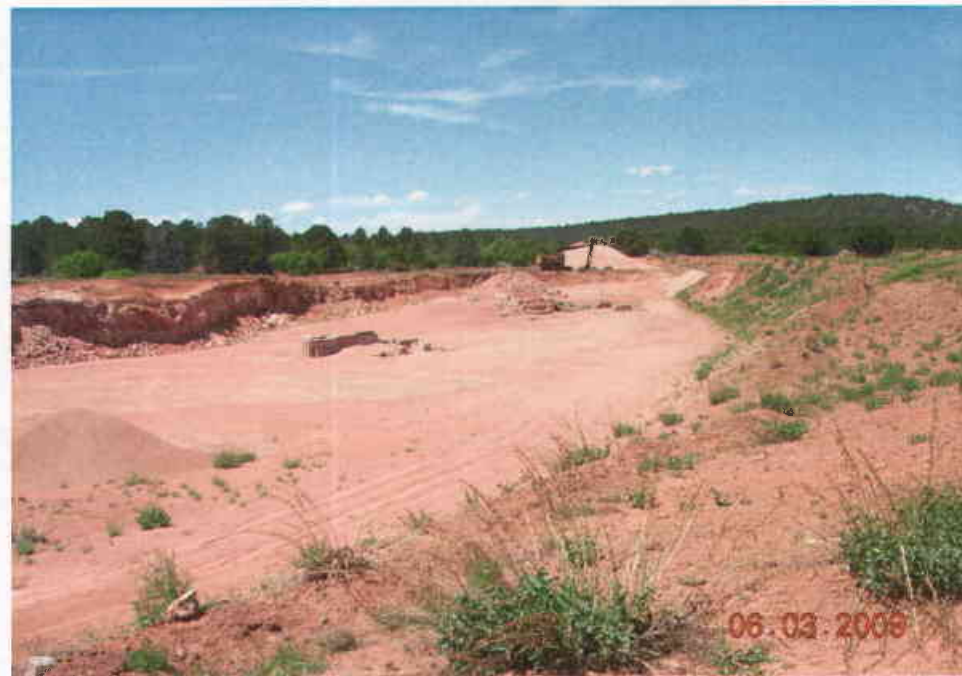
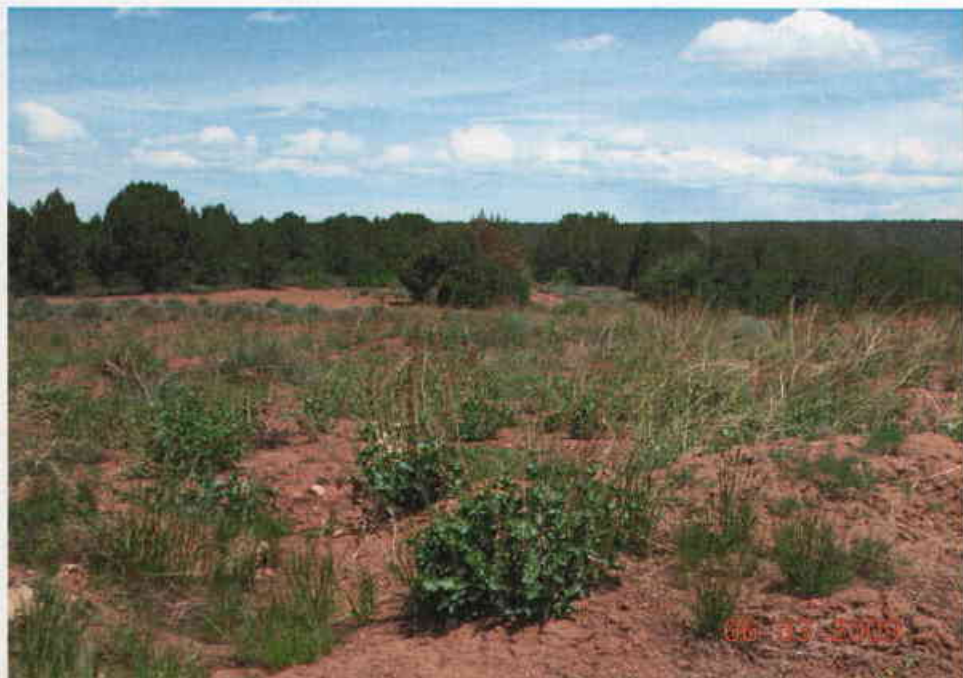
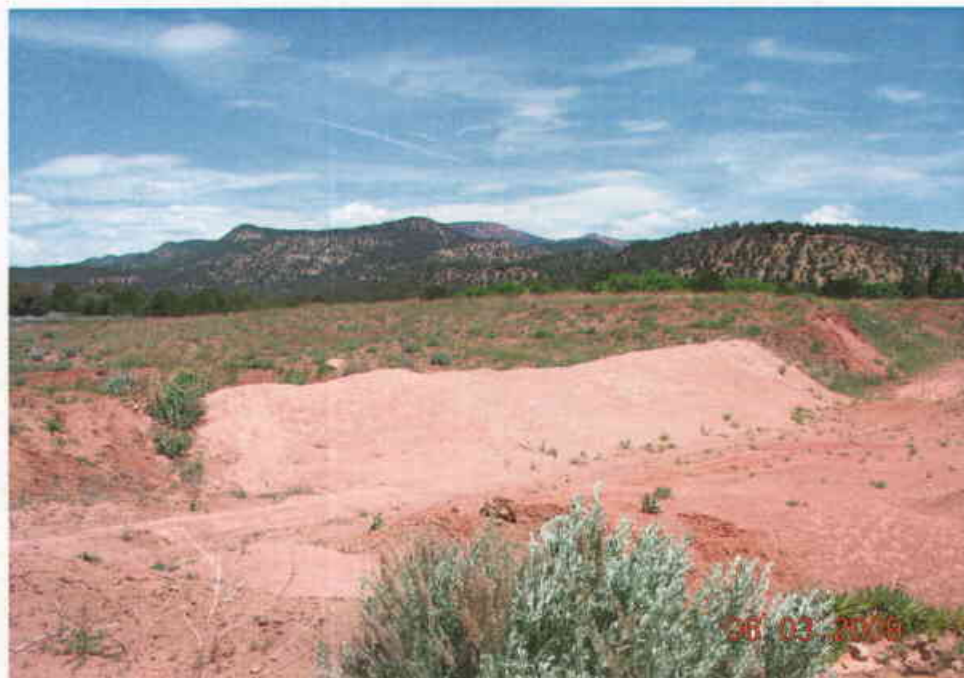
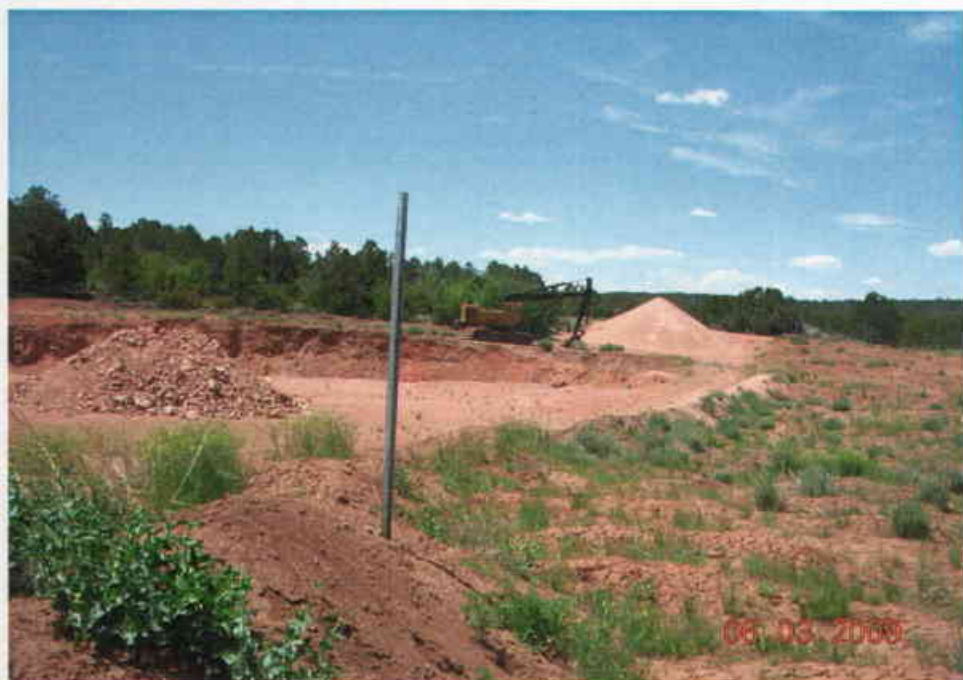
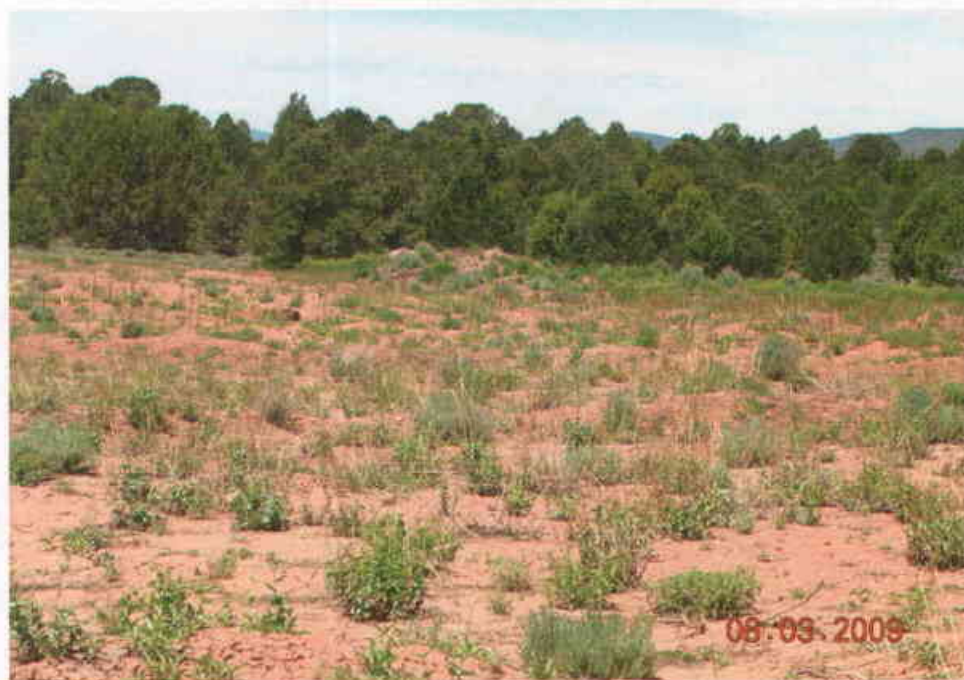
Inspection of the site found some empty barrels and other trash – a subsequent phone call to the operator requested that these be removed or properly stored.

Approximately 4.2 acres were reclaimed in 2005. This area was inspected to determine whether reclamation success standards have been met. The area is stable with no signs of erosion. The area is free of trash and debris. Grading of the site blends in with surrounding terrain. Vegetation is well established and was estimated to have 30% ground cover. This compares to the surrounding vegetation ground cover of 28%. Dominant vegetation includes palmer penstemon, sagebrush, thickspike wheatgrass and globemallow.

Photos were taken to document site conditions.

The 4.2 acres that were reclaimed meet reclamation success standards and can be released. This action will reduce the disturbed acreage to less than 5 acres, which is in compliance with a small mining operation.

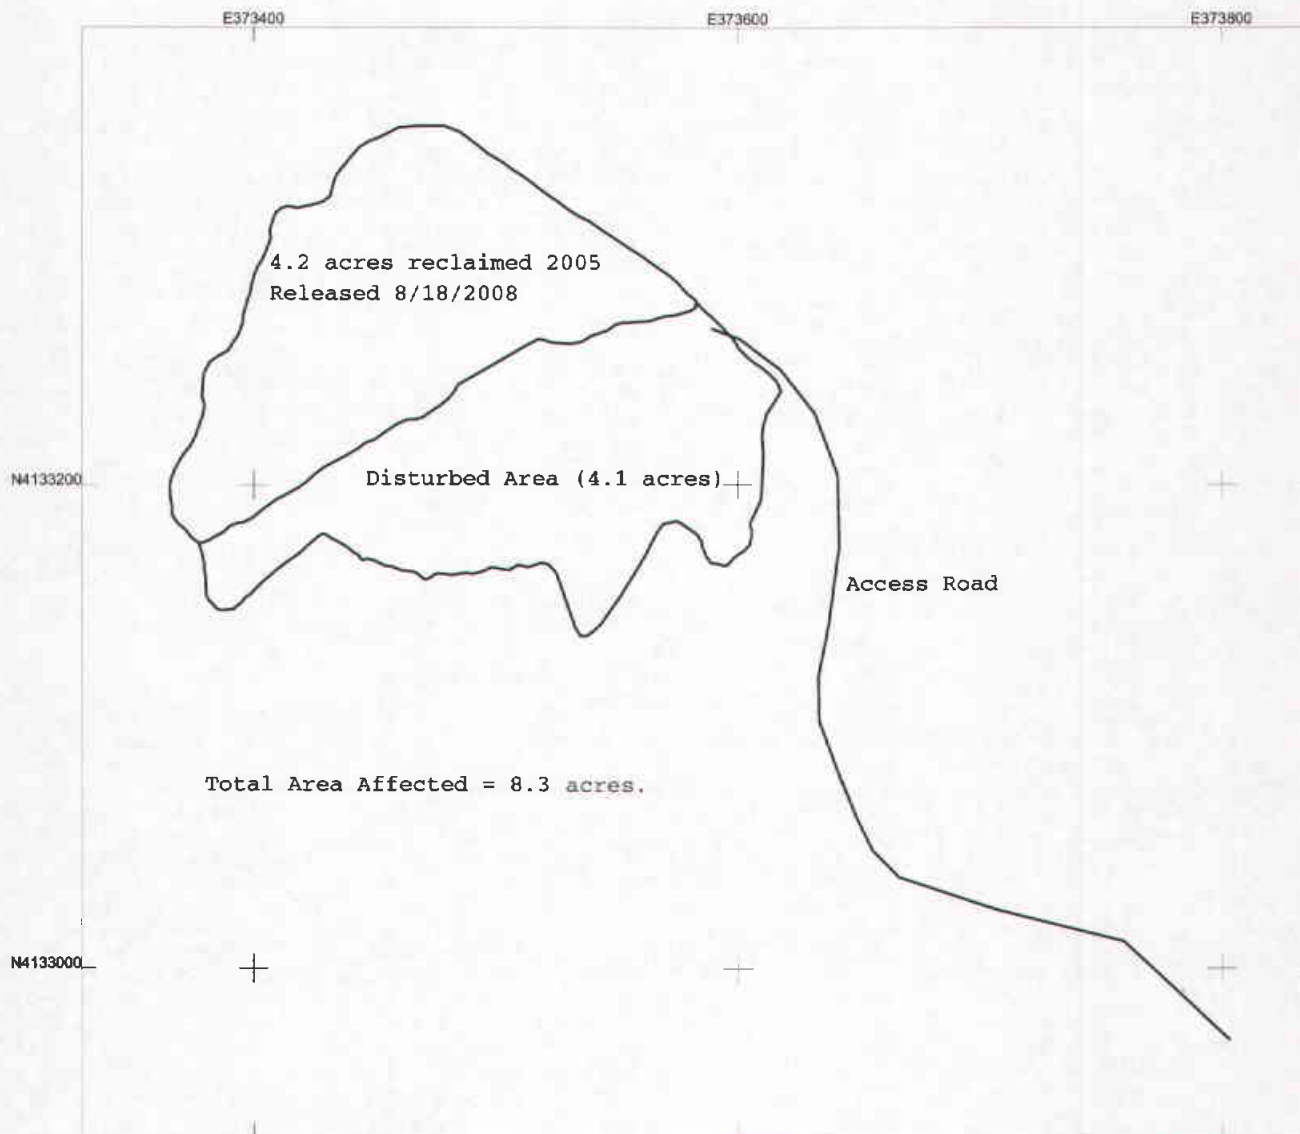
Status of
S/025/0012

The areas was surveyed with a GPS data logger. Total disturbance was found to be 8.3 acres, of which 4.2 acres were reclaimed.
